2019 CAPITAL FACILITIES PLAN

Rice Fergus Miller Architecture

Adopted by the CKFR Board of Commissioners on November 12, 2019

RE: Capital Facilities Plan

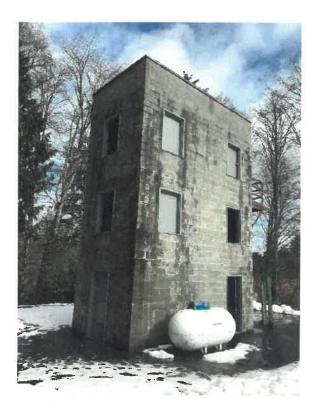
On the north side of the station's parking lot is a three-story training tower. The structure is in poor condition and at risk of collapse in the event of a design-level earthquake.

- The training tower is at risk of collapse after a design-level earthquake
- Inadequate storage for equipment and supplies throughout station
- Materials and finishes are worn out, especially in restrooms and kitchen some have been in place for 40 years

The Fire Station 41 Training Tower is a three-story, concrete masonry structure. The building is located on Old Military Rd NE, west of Washington State Route 303, on the grounds of Fire Station 41 of the Central Kitsap Fire and Rescue. The structure is rectangular at every level, measuring approximately 20 feet by 10 feet in dimension. The second story is approximately 8 feet tall and contains several windows and a diaphragm opening for metal stairs. The third story is approximately 17 feet from the foundation and resembles the second story, with the addition of a door and metal balcony on the east face of the structure. The flat roof of the building is 26 feet above the foundation and includes a small stair access and parapet. Building construction consists of concrete diaphragms, supported by steel framing and reinforced CMU walls. The roof and third level of the structure both consist of cast-in-place concrete on metal deck diaphragms supported by steel framing, while the second level consists of a cast-in-place concrete diaphragm supported directly by the CMU walls. The foundation of the structure consists of strip footings.

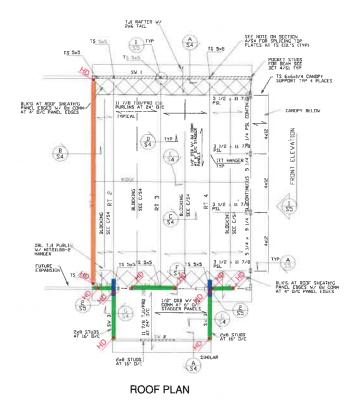
Irrespective of a more-detailed evaluation, Figures 3.1-3 displays the schematic-level upgrade concept to improve the LFRS of Fire Station 42 to meet the IO performance objective.

The upgrade approach involves adding shear strength to the building by upgrading existing wood shear walls and increasing the strength of the connections between the roof trusses at the apparatus bay dragging load to the wood shear walls. Modifications to the foundation systems may be required for the existing upgraded walls.

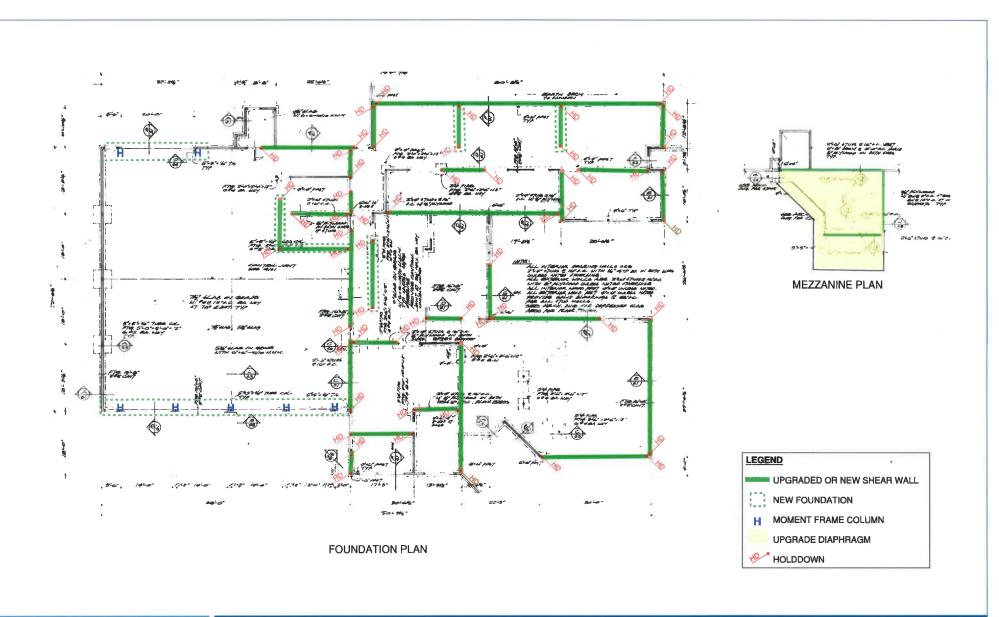
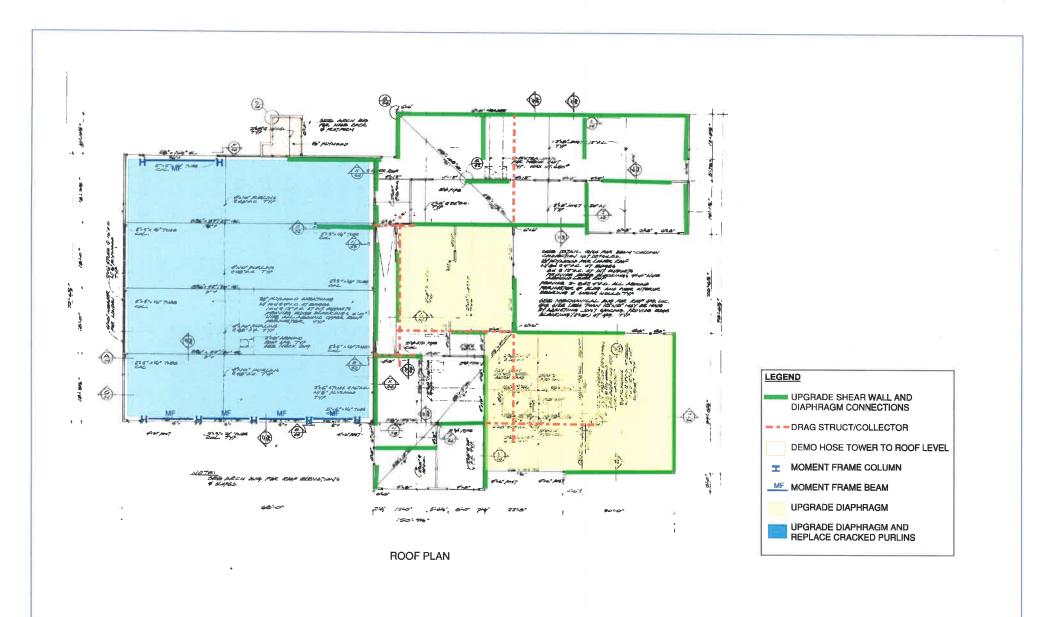
Supplementary nailing and blocking are added to the roof to increase the roof diaphragm's capacity and strength. This includes the apparatus bay roof and the lower roof. The connection between the diaphragm and shear walls should also be improved using roof-to-wall ties to ensure

the forces are transferred to the shear walls. This upgrade will increase the diaphragm's stiffness and the diaphragm's shear capacity. All roof joists showing signs of shrinkage cracking should be upgraded or replaced. Drag struts and collectors are also being added to strengthen reentrant corners in the roof diaphragm and to adequately transfer seismic loads to wood shear walls.

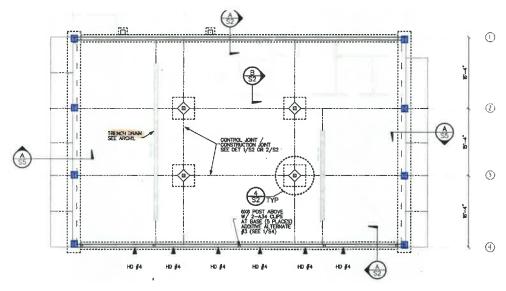
Supplementary nailing and blocking are added to the apparatus bay roof to increase the roof diaphragm's capacity and strength. The connection between the diaphragm and shear walls and moment frames should also be improved using roof-to-wall ties to ensure the forces are transferred to the shear walls. This upgrade will increase the diaphragm's stiffness and the diaphragm's shear capacity.
