2019 CAPITAL FACILITIES PLAN

Rice Fergus Miller Architecture

Adopted by the CKFR Board of Commissioners on November 12, 2019

RE: Capital Facilities Plan

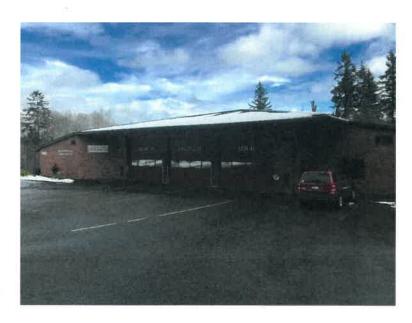
Fire Station 41 is a one-story, wood-framed structure with a concrete below-grade basement. The building site is located on Old Military Rd NE, west of Washington State Route 303, and slopes downhill from south to north. The building is irregular in shape, with a below-grade level on the north side of the structure. The overall dimensions of the building footprint are approximately 100 feet by 145 feet. The ridge height of the roof above the apparatus bay is 21 feet, while the ceiling height of the surrounding areas is approximately 8.5 feet. A hose tower in the southeast corner of the building rises to a height of approximately 27 feet. The main level of the structure consists of glulam beams, I-joists, and wood structural-panel diaphragms supported by wood shear walls and concrete retaining walls. The exterior walls of the main level support a brick veneer. The basement consists of a wood-framed flooring system supported by concrete retaining walls. The hose tower is constructed of a flexible wood-framed diaphragm supported by concrete masonry unit (CMU) walls and concrete retaining walls. The foundation system consists of strip footings throughout the structure.

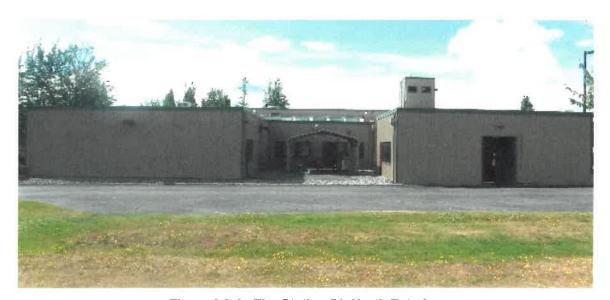
Figure 3.3-1. Fire Station 51, North Exterior.

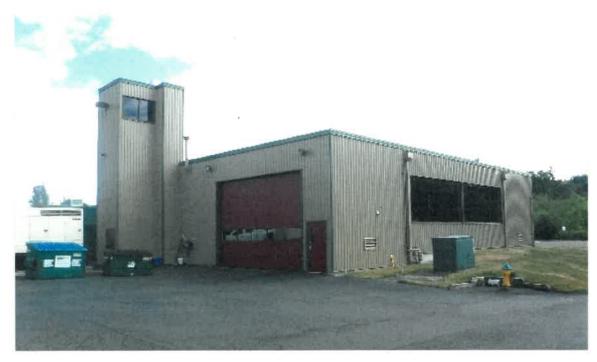
Figure 3.3-2. Fire Station 51, Exterior looking Northwest.

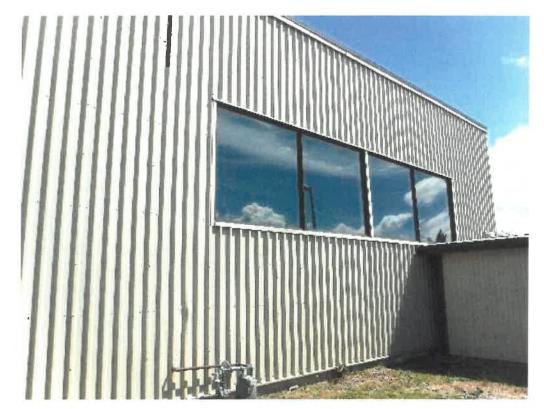
Figure 3.4-1. Fire Station 51 Maintenance Building, South Exterior.

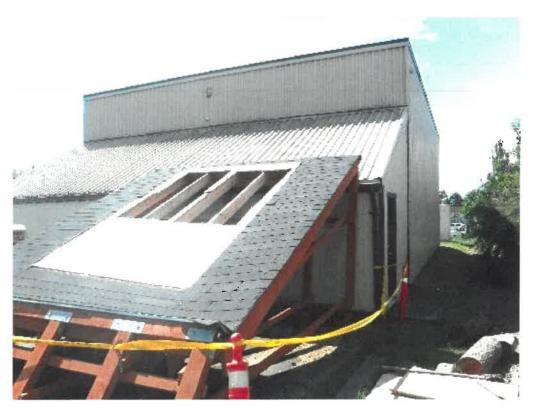
Figure 3.4-2. Fire Station 51 Maintenance Building, Roof Prop Leaning on North Exterior.
